US Army Corps  
of Engineers  
Construction Engineering  
Research Laboratories

Technical Report REMR-OM-19  
June 1997

# REMR Management Systems—Navigation and Flood Control Structures, Condition Rating Procedures for Lock and Dam Operating Equipment

by *James H. Stecker, Lowell F. Greimann, Scott Mellema, and Kevin Rens*  
*Department of Civil and Construction Engineering*  
*Iowa State University*

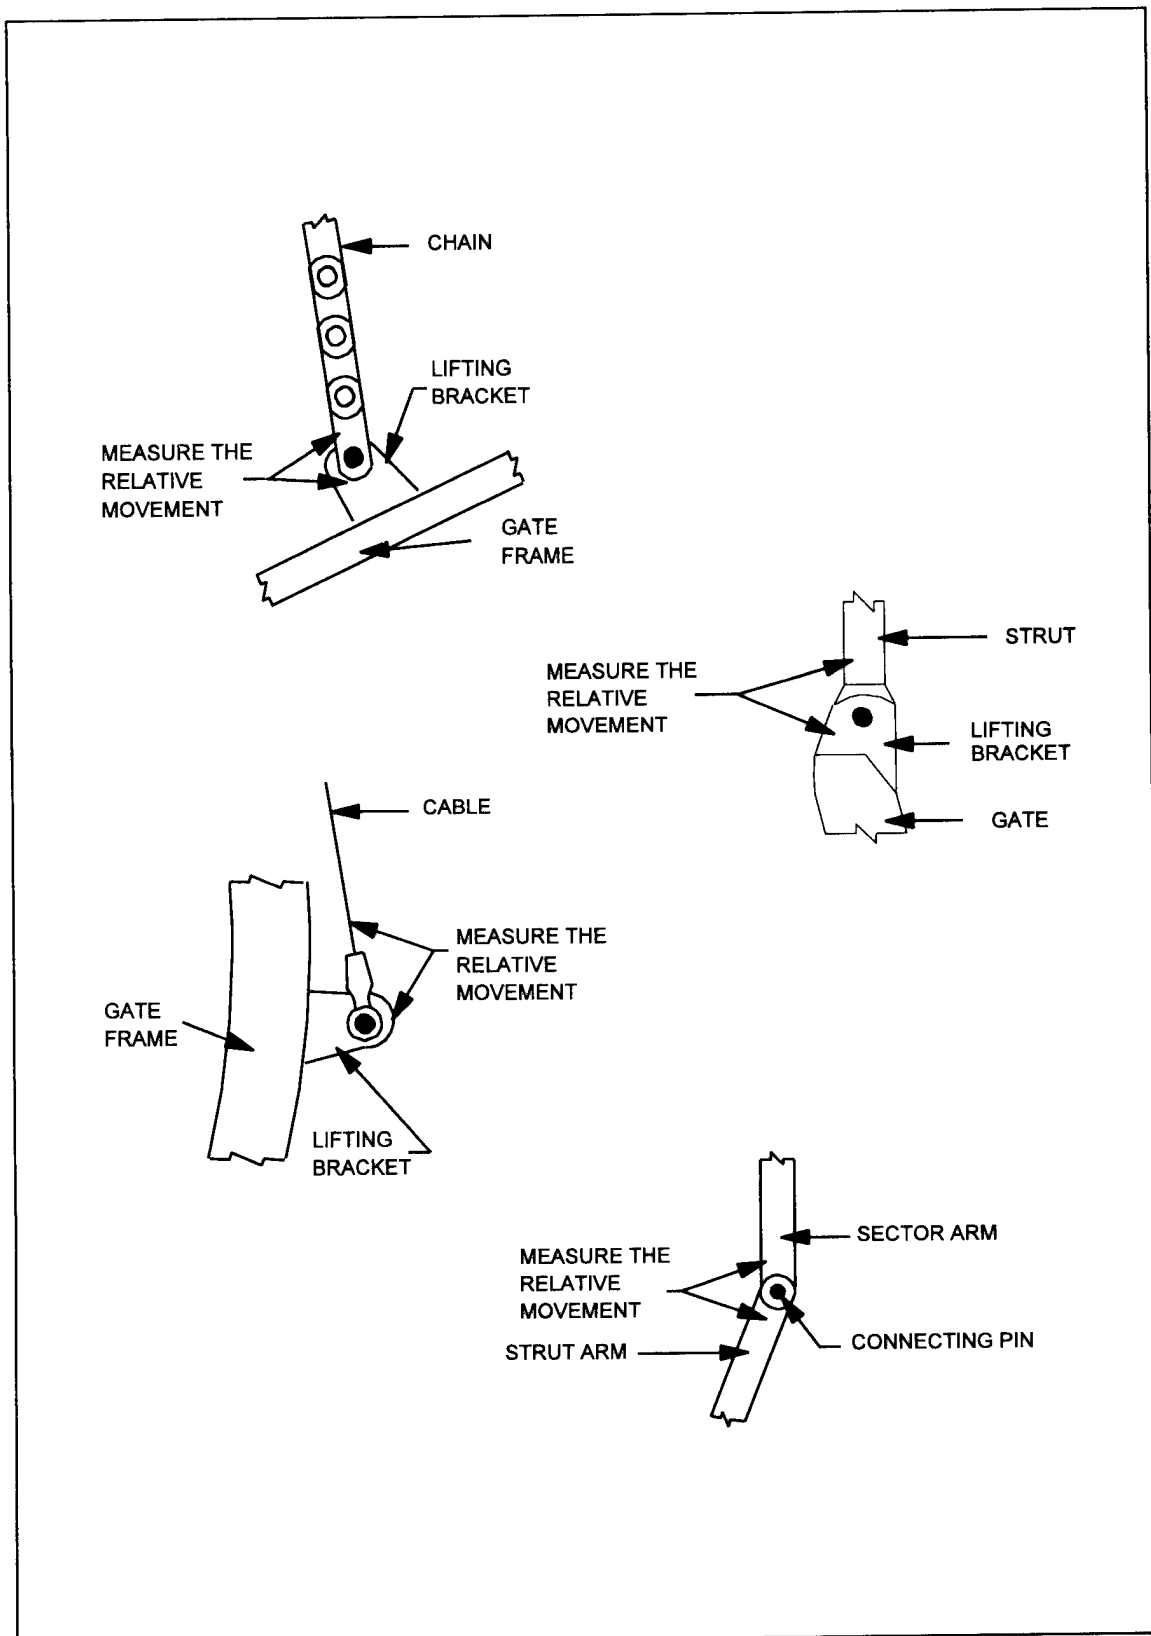
Figure 27. End connection movement distress.

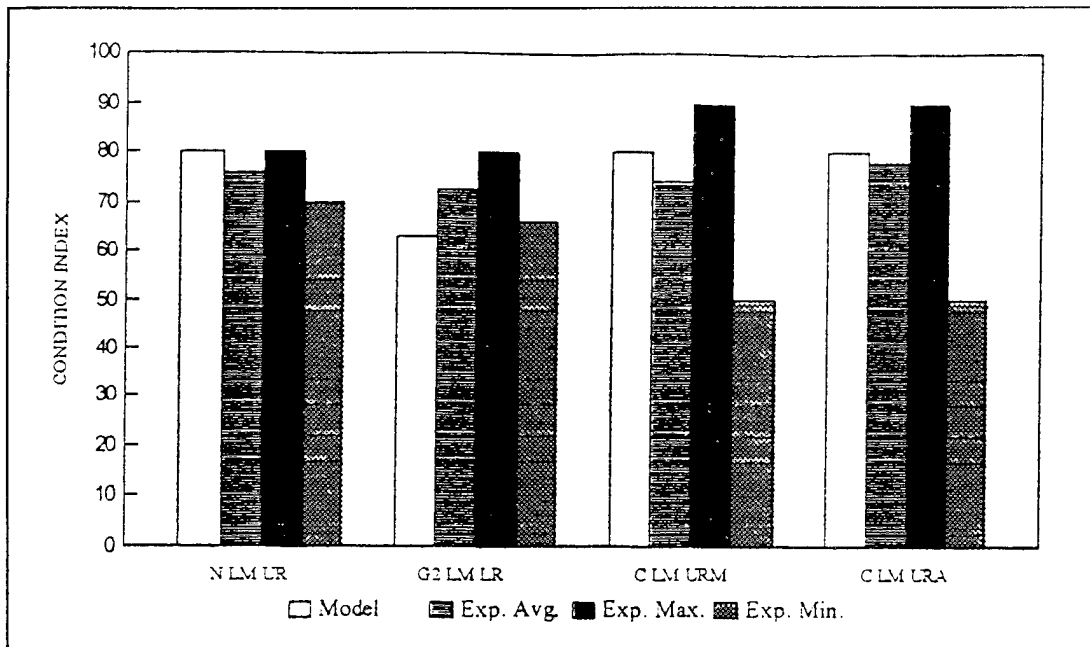
Figure 28. End connection movement: strut arm assembly.

### **End Connection Movement: Figure 28**

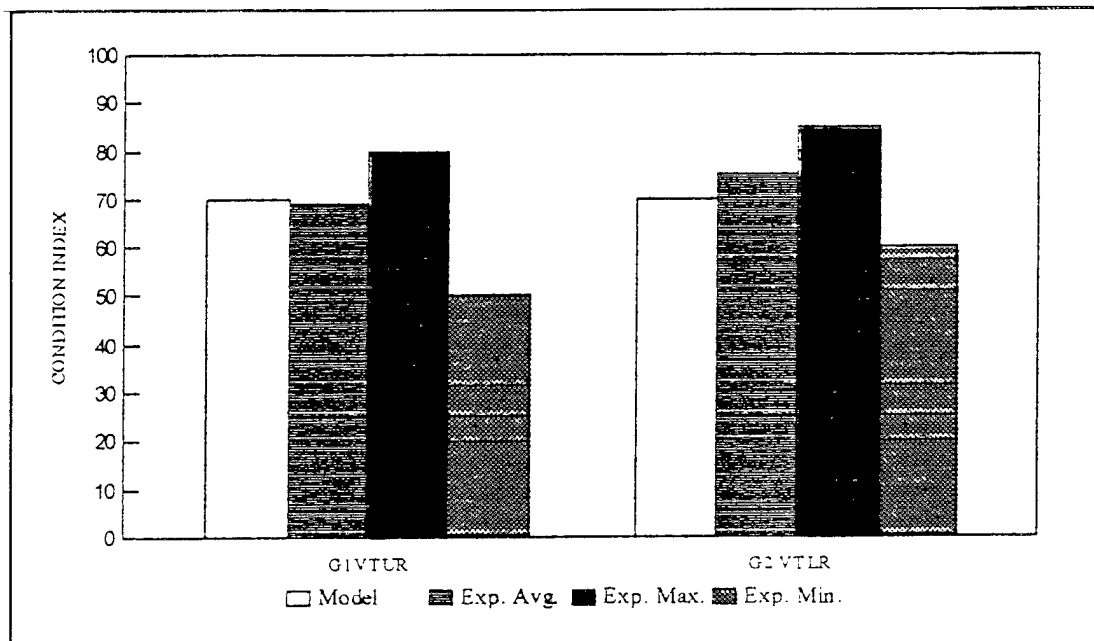
Figure 29. Corrosion: strut arm assembly.

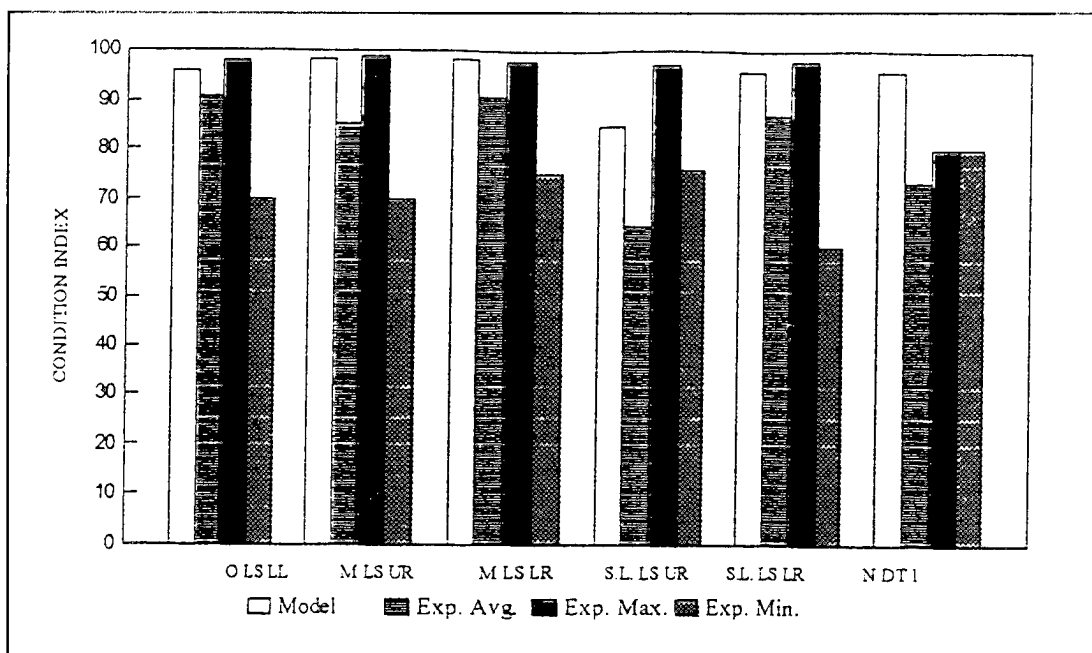
The assembly CI for strut arms was calibrated for six assemblies. In each case, the model CI was higher than the experts' average CI. Although the model CIs were higher, the experts' average CIs and the model CIs were all in Zone 1.

Figure 30. Strut arm assembly CI.

### **Assembly CI: Figure 30**

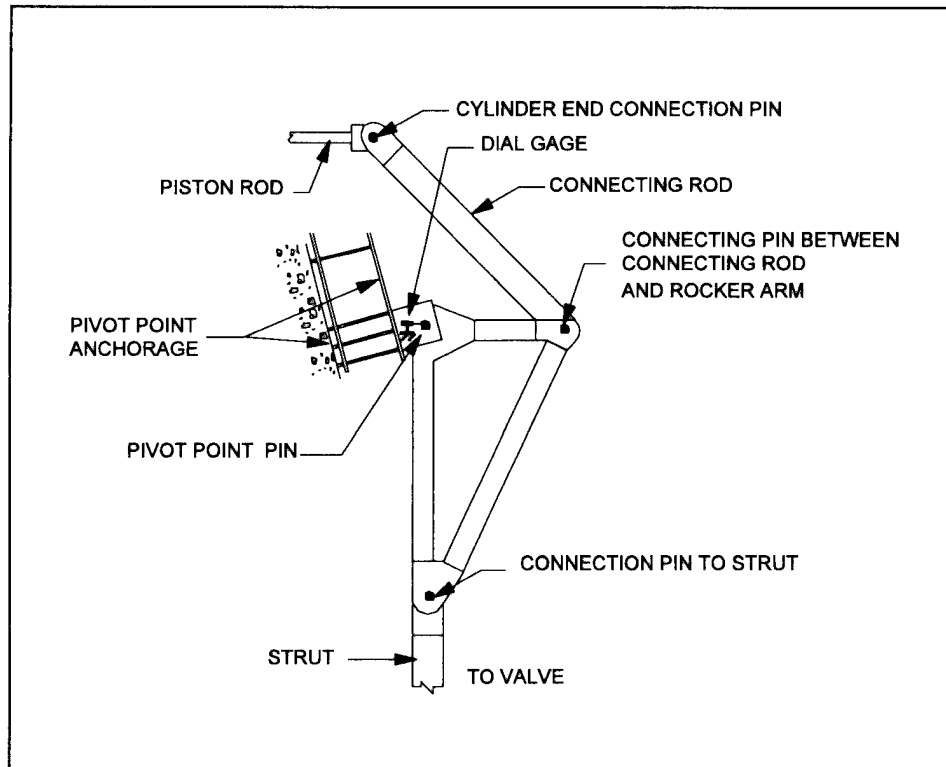
Figure 31. Rocker arm distress measurements.

Record any evidence of MOVEMENT at the ANCHORAGE of the PIVOT POINT as the valve is opened and closed. Evidence of movement can be observed visually or enhanced by placing a dial gage to monitor any movement (Figure 31). A dial gage change greater than 0.002 in. is considered movement. Excessive concrete spalling may indicate a displacement occurred at this location at some time. Also, record the presence of any CORROSION (10% volume loss) of the steel portion or any CRACKED CONCRETE at the interface of the embedment. Small hairline cracks, probably caused by thermal expansion or contraction of the concrete, should be ignored. Indicate if there are any CORRODED (10% volume loss), MISSING OR BROKEN, or LOOSE nuts at this connection if the BOLTS are EXPOSED.

Record the relative MOVEMENT at the PIVOT POINT PIN (Figure 31) between the rocker and the anchorage bracket by visual observation to the nearest 1/8 in. To further enhance the visual observation, place a dial gage at this location.

Record the relative CONNECTION MOVEMENT between the ROCKER AND CONNECTING ROD (Figure 31) by visual observation to the nearest 1/8 in. To further enhance the visual observation, place a dial gage at this location.

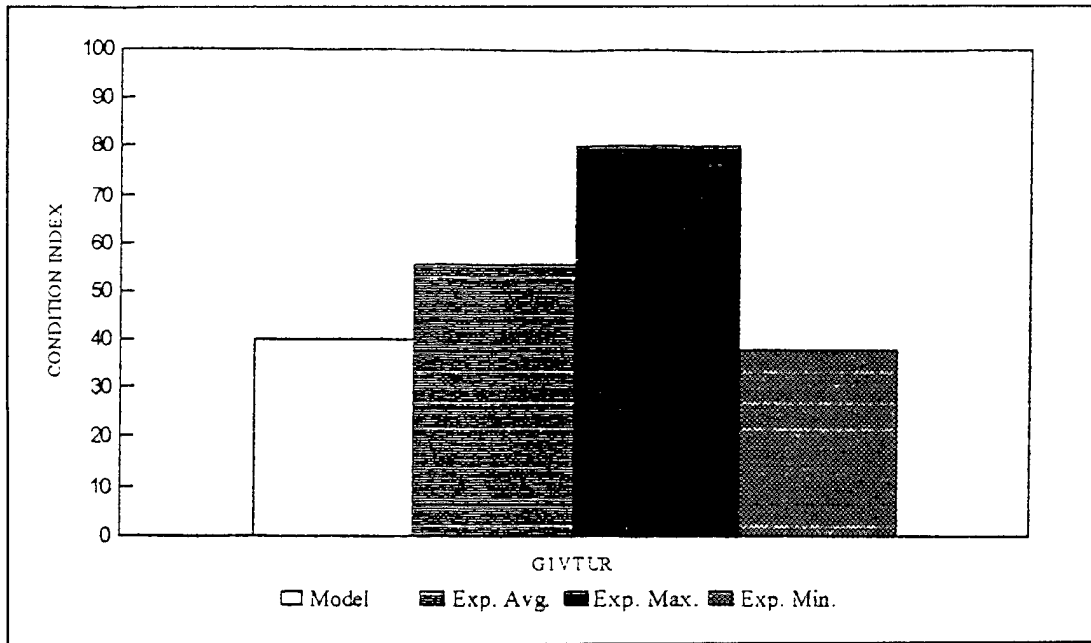
The pivot point anchorage movement/deterioration distress was observed on a filling valve at Green River #1 Lock. The experts' average was 15 points higher than the calculated CI of 40.

Figure 32. Pivot point anchorage movement/deterioration: rocker arm assembly.

The bar charts in Figures 32 and 33 compare the experts' subjective condition index from the field tests with the CI calculated from the rules in Section 8.3 for two rocker arm distresses. Only data from assemblies with observed distresses are plotted. Comparisons between the calculated and experts' CIs are summarized below.

### **Pivot Point Anchorage Movement/Deterioration: Figure 32**

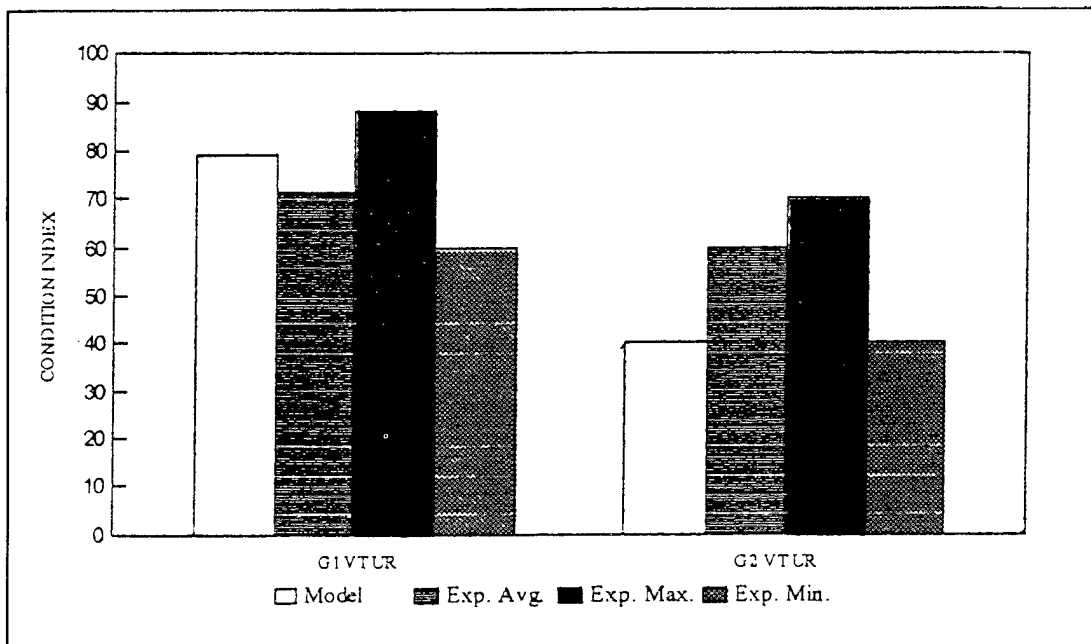
Figure 33. Pivot point pin movement: rocker arm assembly.

### **Pivot Point Pin Movement: Figure 33**

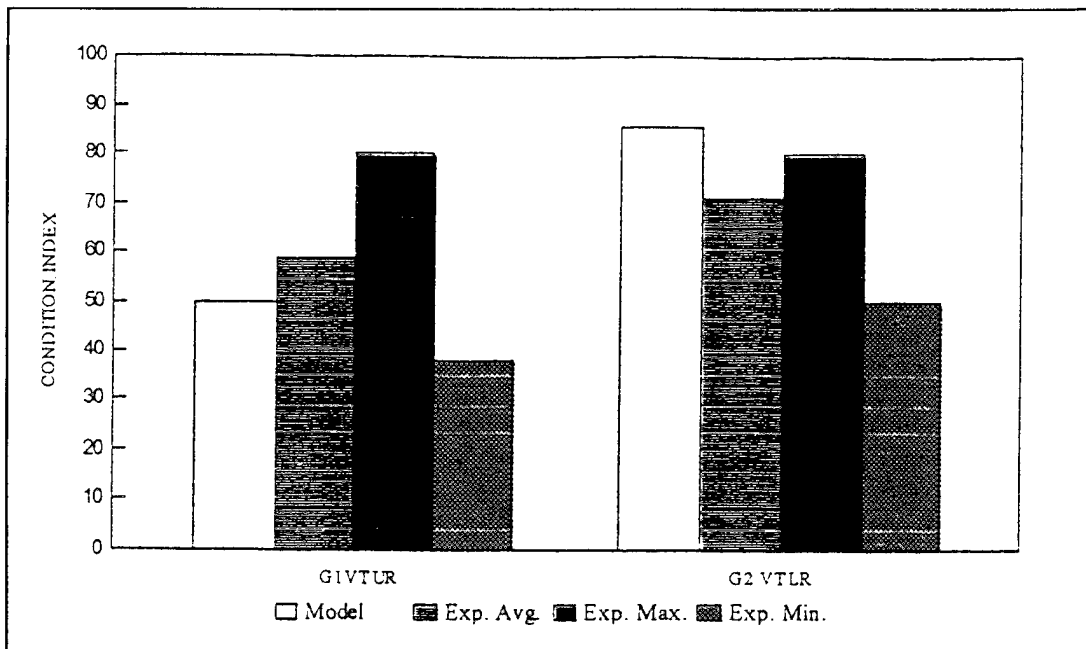
Figure 34. Rocker arm assembly CI.

### **Assembly CI: Figure 34**

The assembly CI for rocker arms was calibrated for two assemblies. The model CI was slightly lower than the experts' average CI for the case in Zone 2 (Upper Right Valve Green River #1), and was higher than the experts' average CI for the case in Zone 1 (Lower Right Valve Green River #2).

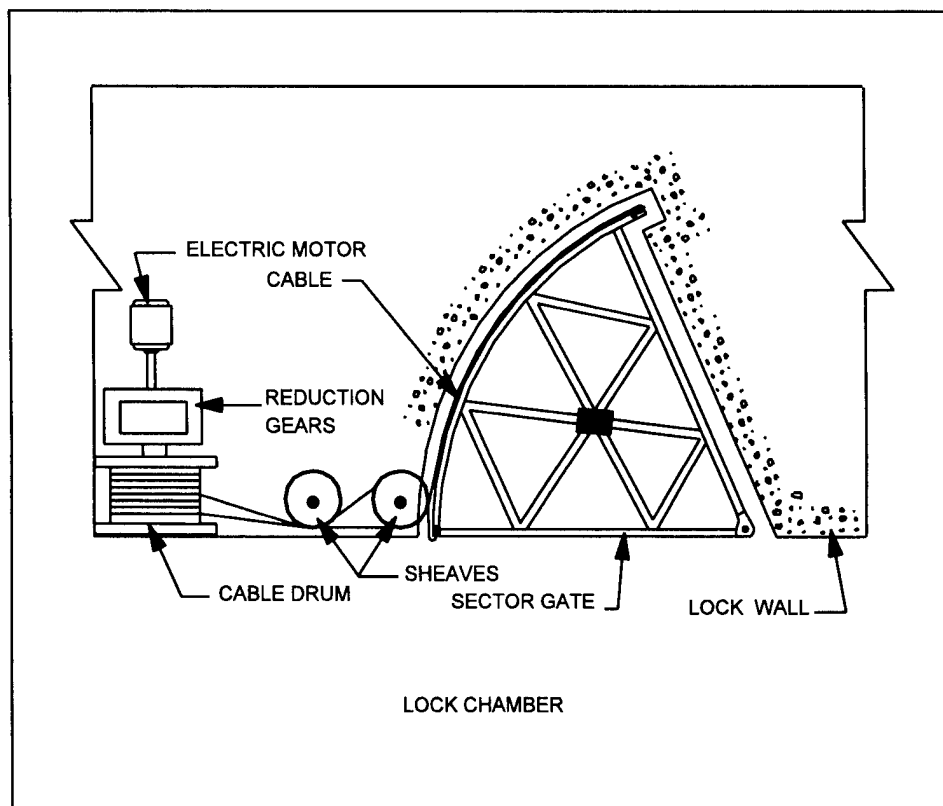
Figure 35. Plan view of sector lock gate operating equipment.

Definitions and sketches for components of the cable assembly are presented in the following paragraphs. Cable lifting systems are sometimes used to raise and lower or open and close the structures (Figures 35, 36, and 37).

The cable drum is the component around which the cable is wound as the valve structure is raised and lowered or the gate is moved (Figures 35 and 39).

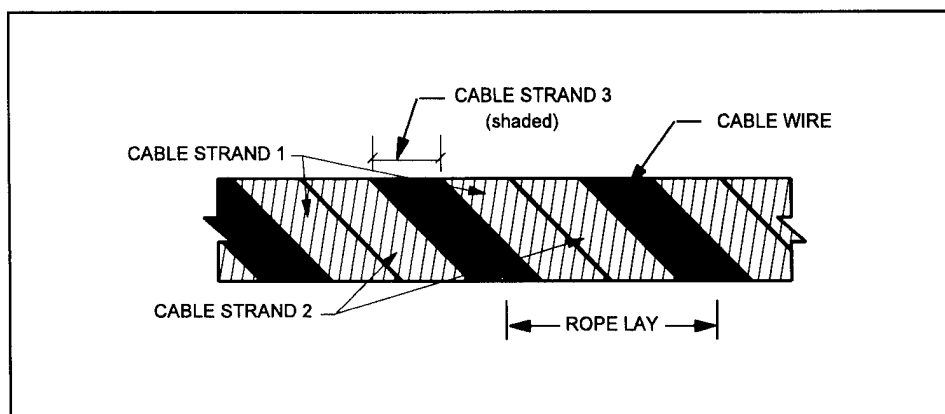
Figure 38. Cable schematic.

The cable is made up of several strands (Figure 38) usually wound in one of two ways: regular or lang lay. The wires of a regular lay are twisted to make the strands, and the strands are then twisted in the opposite direction to make the rope. The wires in the regular lay end up running in the longitudinal direction. Figure 38 shows a lang lay, where the wires and strands are twisted in the same direction.

The cable strand is composed of several wires wrapped together in various arrangements (Figure 38).

Record the maximum number of BROKEN WIRES in all strands of any ONE ROPE LAY (Figure 38). Also indicate the LOCATION of the broken wires from the power end of the cable (Figure 40).

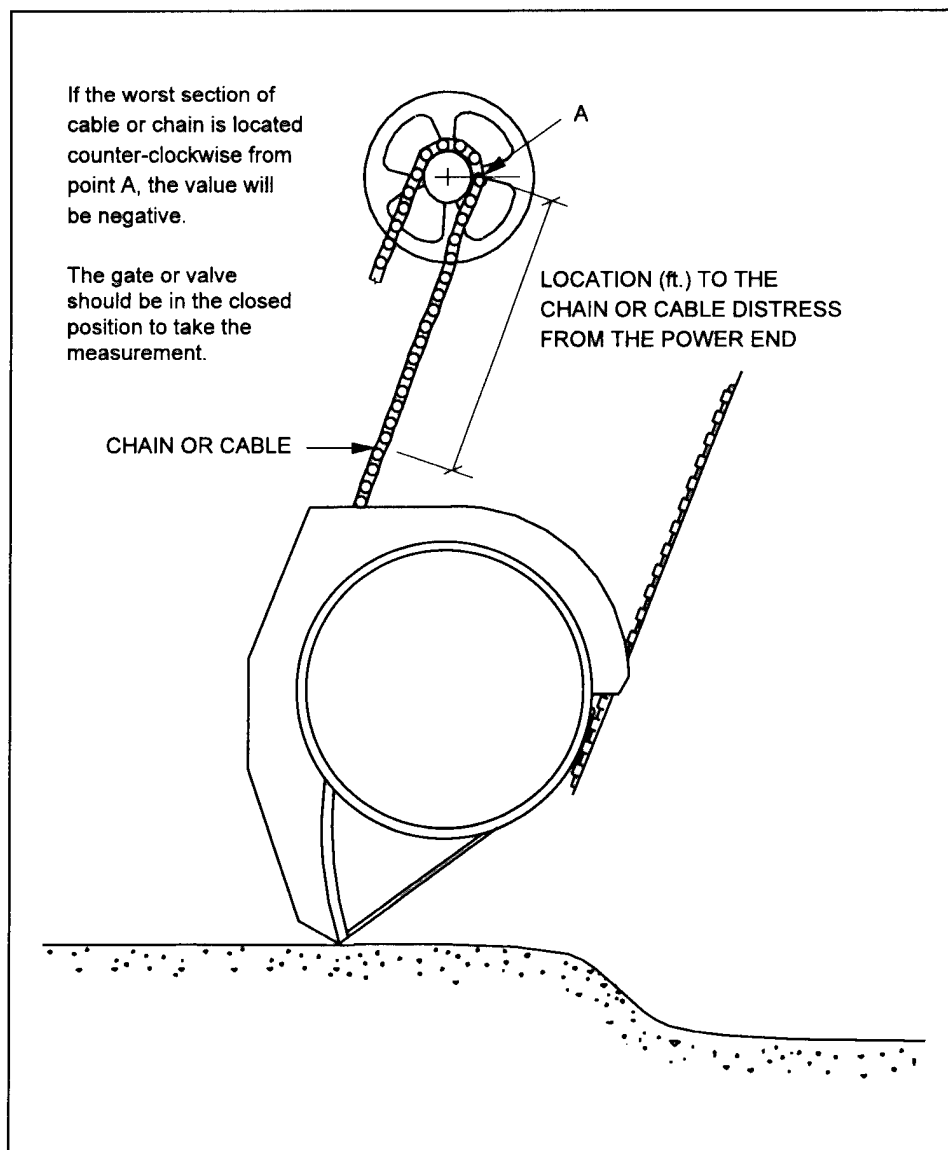
Figure 40. Location identification for cable and chain distresses.

Record if a WORN PORTION of the outer cable WIRES is evident. If wear is evident, record the average PERCENTAGE of WEAR of the wire diameter on the outer wires. The wear would most likely occur near the drum when the gate is in the opened or closed position. Also indicate the LOCATION of the worn section from the power end (Figure 40\*).

A BIRD CAGE is a local area of unraveled portion of the cable (Figure 41). Record the existence of BIRD CAGES, KINKS, OR PROTRUDING CORES (Figure 42) on the inspection form. Indicate the type of distress (a bird cage, a kink, or a protruding core) if one of the three exists. Also record the LOCATION from the power end that this distress occurs (Figure 40).

Record any existence of UNLAYED cable STRANDS. Unlaid strands occur when the cable rubs against an object. Unlaid strands are the strands displaced from the uniformly distributed manufactured position. Also indicate the LOCATION of the unlaid strands from the power end (Figure 40).

Record the NUMBER OF CRACKS in the chain links. Also record the LOCATION of the cracked links from the power end (Figure 40).

Many times after a structure has been in the same position for some time, the links will lock together and not bend around the sprocket. Record a yes (Y) if the chain will not bend around the sprocket or, in other words, the chain LINKS are FROZEN. If links are frozen, they will often remain bent in the shape of the sprocket after they have been loaded. If there are frozen links, record whether they cause LIMITED OPERATION of the structure. The structure may have to be raised higher than normal to check the probable problem links. Also record the LOCATION of the frozen links from the power end (Figure 40).

The presence of excessive CORROSION on the chain is a potential problem. Record YES if there is SIGNIFICANT CORROSION (more than general scaling). If yes, indicate if there is SEVERE PITTING (1/8 in. pits or greater) in a dense pattern or GENERAL THICKNESS REDUCTION of 10% or greater in local areas. Also record the LOCATION of the corrosion from the power end (Figure 40).

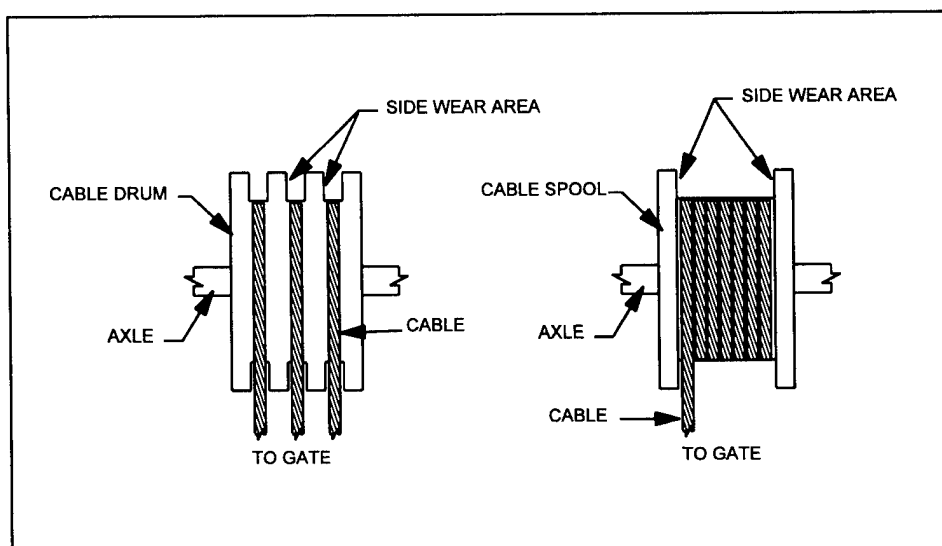
Figure 43. Cable drum wear.

For DRUMS, record if there is VISIBLE GROOVE WEAR. Groove wear is the wearing of the bottom of the grooves. If there is groove wear, estimate the DEPTH OF the GROOVE WEAR in percentage of the CABLE DIAMETER. If the estimate of groove wear is GREATER THAN 10% of the cable diameter, use an appropriate method to MEASURE the groove wear. Groove wear can be measured by placing a cable groove template into the groove and observing the gap between the bottom of the groove and the template. A similar procedure that can be used is to place a piece of new cable into the groove and to measure the gap. Indicate whether there is SIDE WEAR on the drum. If the cable is misaligned, the guide plates will show the imprint of the cable (Figure 43).

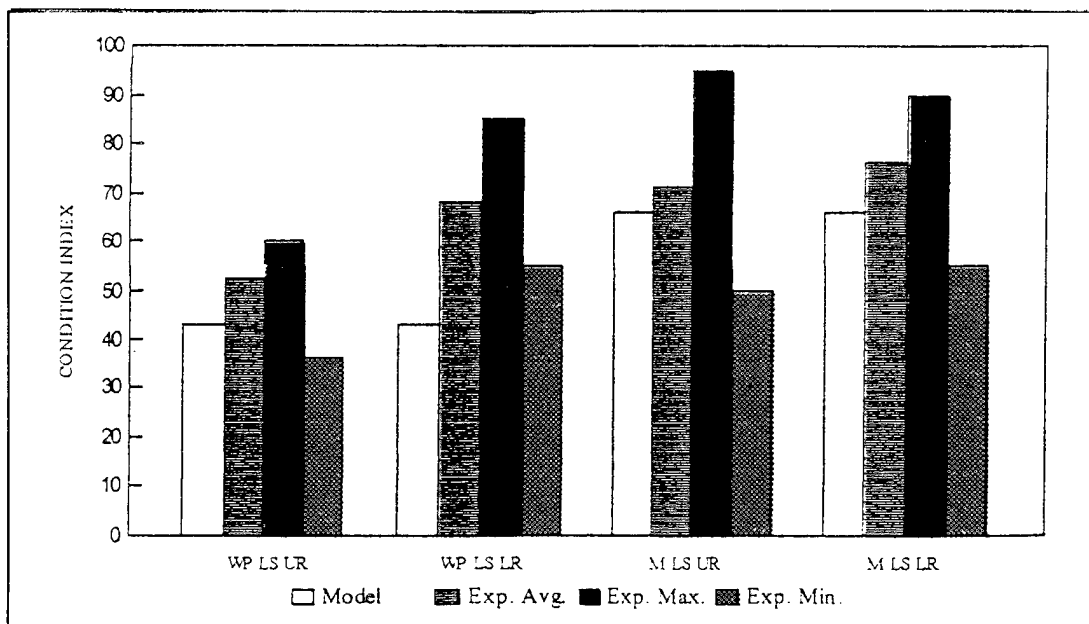
Figure 44. Outer wire wear: cable assembly.

The bar charts in Figures 44 and 45 compare the experts' subjective CI from the various field tests to the CI calculated from the rules in Section 9.3 for two cable distresses. Only data from assemblies with observed distresses were plotted. Comparisons between the calculated and experts' average CIs are summarized below.

#### Outer Wire Wear: Figure 44

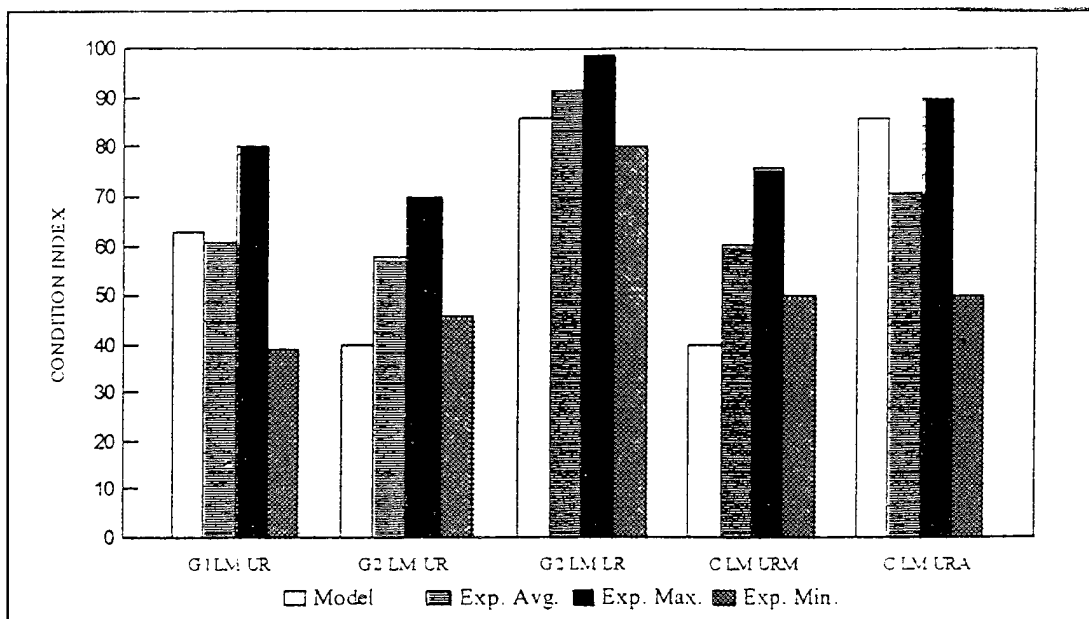
Figure 45. Wire breakage: cable assembly.

### **Wire Breakage: Figure 45**

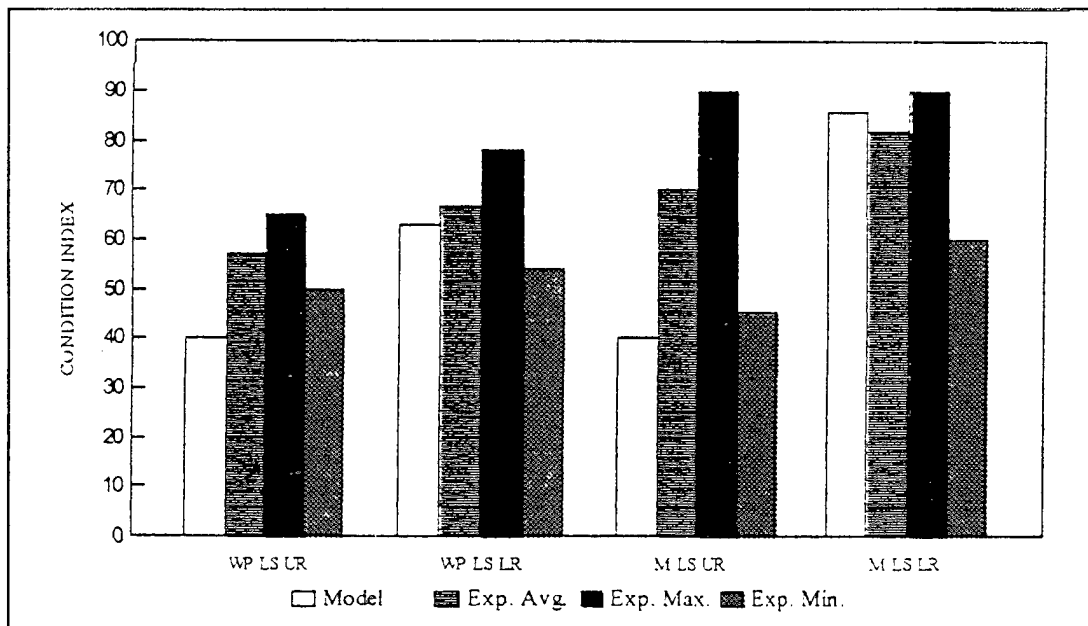
Figure 46. Cable assembly CI.

### **Assembly CI: Figure 46**

The assembly CI for the cable assembly was calibrated for four assemblies. For two of the assemblies, the model CIs were significantly lower than the experts' average CIs, and for the other two calibrated assemblies, the model CIs closely approximated the experts' average CIs. In only one case (Upper Right Sector Lock Gate Moorehaven) did the model CI and the experts' average CI fall into a different zone. In all four cases, wire breakage (a critical distress) controlled the assembly CI.

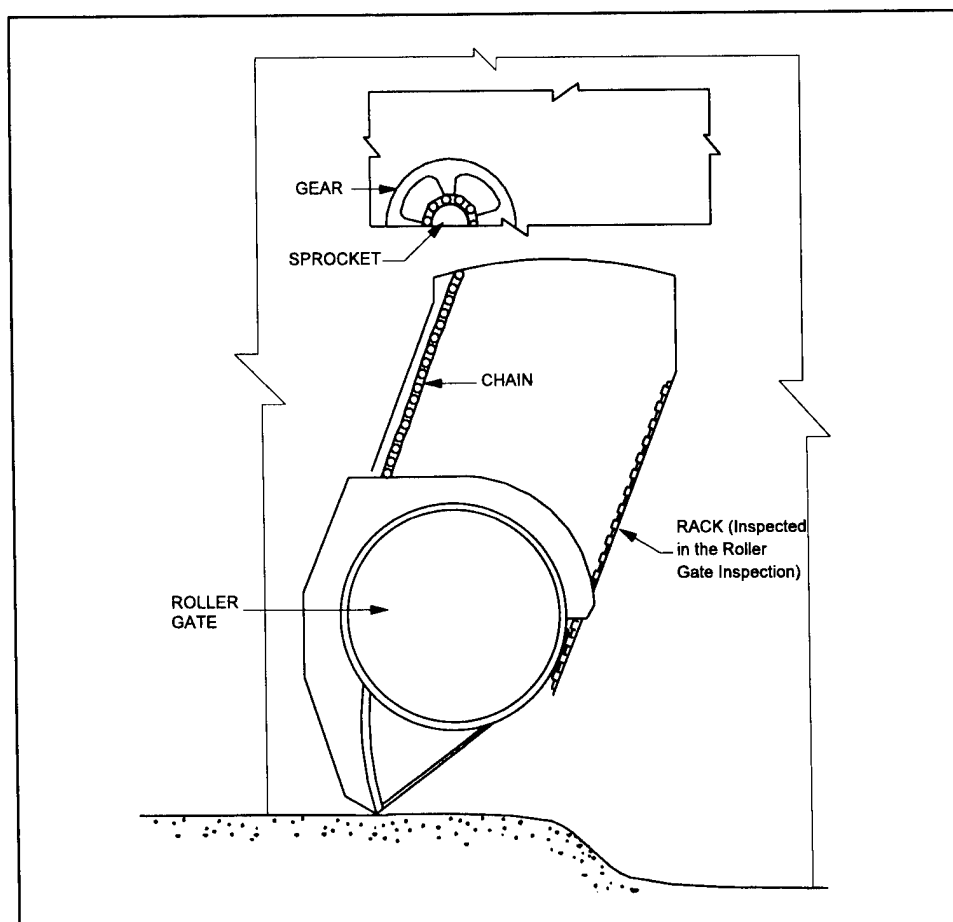
Figure 47. Side view of roller dam gate operating equipment.

A chain is a series of links connected to one another. Chain lifting systems are sometimes used to raise or lower dam or lock structures (Figure 47). The chain gets lifted and wound over a sprocket type device during the operation of the assembly.

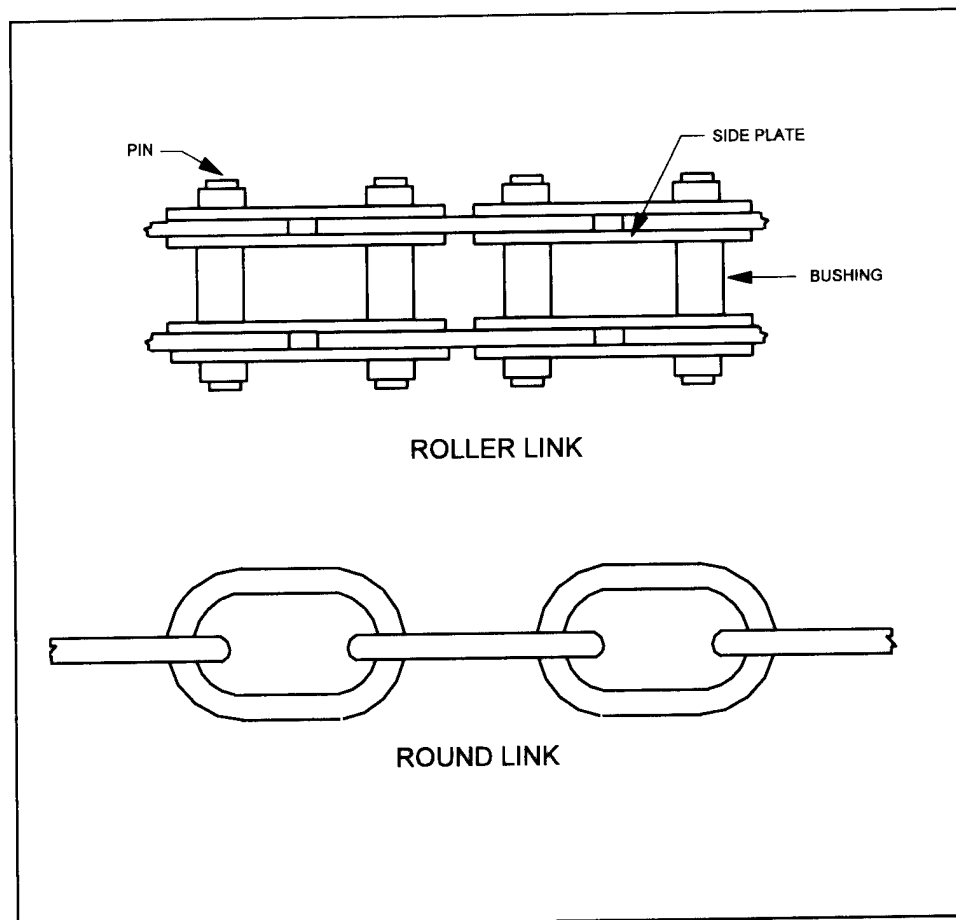
Figure 48. Chain link schematic.

The sprocket is the component that retrieves the chain as it rotates. The chain links fit on the sprocket teeth.

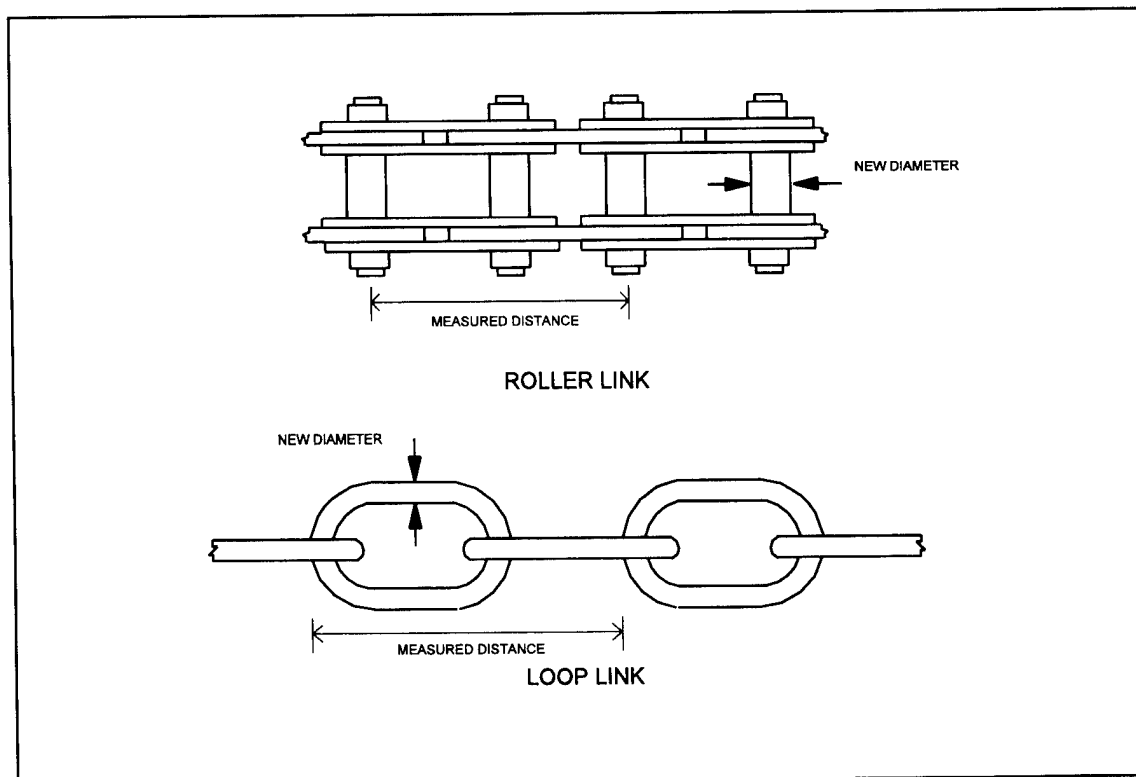
Figure 49. Chain linkage wear.

LINKAGE WEAR/ELONGATION of the chain occurs between the links of the chain (Figure 49). Record the LENGTH OF WORN/ELONGATED LINKS. This distance can be measured on a roller link chain by placing a tape measure along the loaded chain and measuring from the center to center of several consecutive link pins (Figure 49). For a round link, measure from end to end of the links while the chain is loaded (Figure 49). To get a more accurate estimate of total wear and elongation, measure 10 to 20 consecutive links and divide the measured distance by the number of links. The worst worn or elongated links will most likely be those that ride on the sprocket most frequently, if the gate operates at a relatively constant elevation. Also record the LENGTH OF NEW LINKS. This distance can be obtained from construction drawings. If construction drawings are not available, measure the distance between links that get little use, and use this distance as an estimate of the distance between new links.

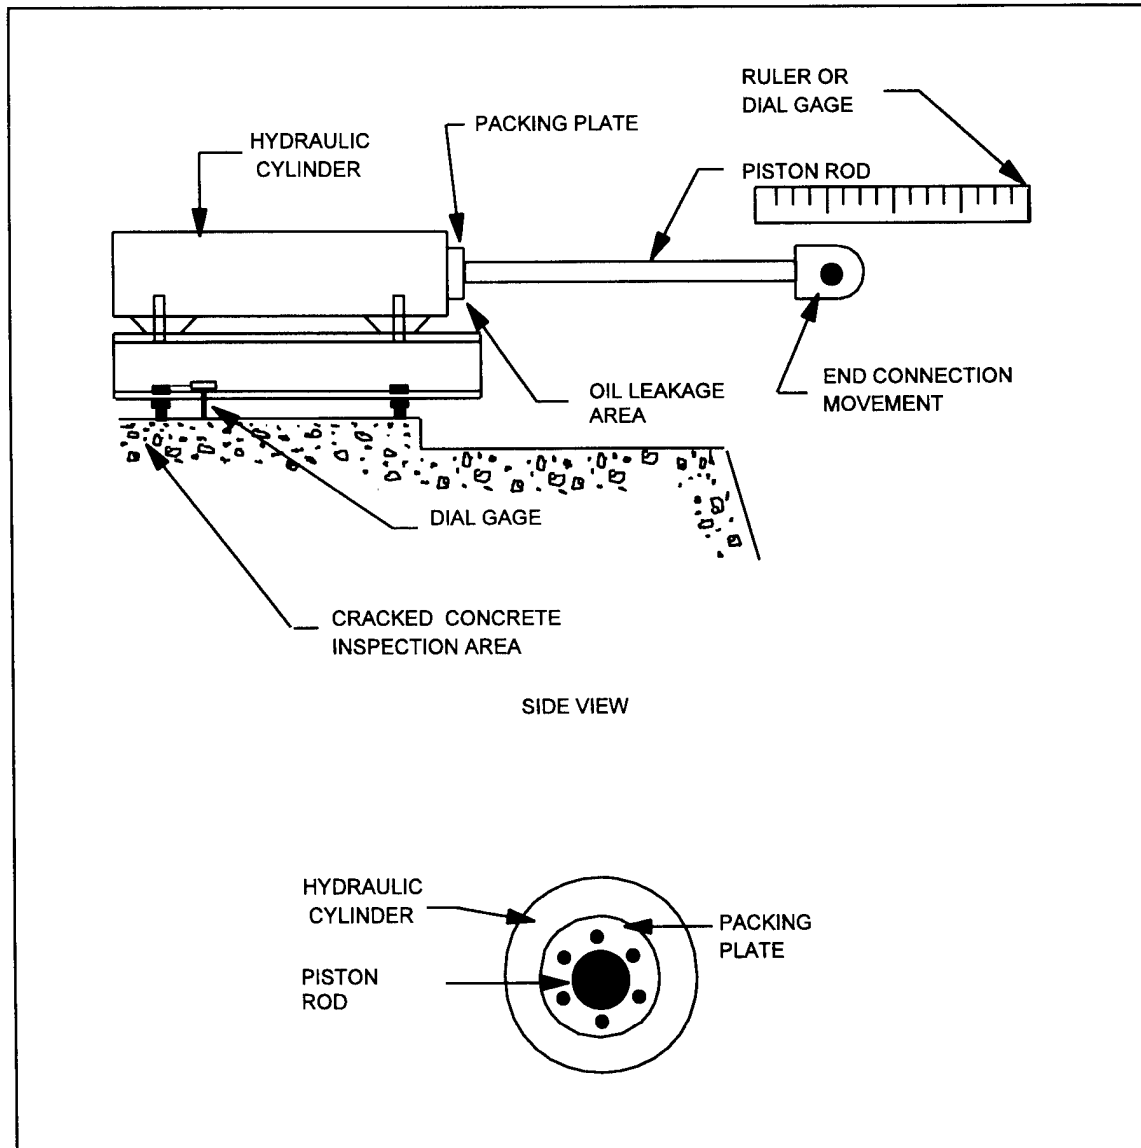
Figure 50. Hydraulic cylinder assembly distress measurements.

Record any evidence of MOVEMENT greater than 0.002 in. at the ANCHORAGE as the gate or valve is opened and closed. Evidence of movement can be observed visually or enhanced by placing a dial gage to monitor any movement (Figure 50). Excessive concrete spalling may indicate a displacement occurred at this location at some time. Also, record the presence of any CORROSION (10% volume loss) of the steel portion or any CRACKED CONCRETE at the interface of the embedment. Small hairline cracks, probably caused by thermal expansion or contraction of the concrete, should be ignored. Indicate if there are any CORRODED (10% volume loss), MISSING OR BROKEN, or LOOSE nuts at this connection if the BOLTS are EXPOSED.

Record any EVIDENCE OF RECENT OIL LEAKAGE. Record the NUMBER OF OIL DROPS that leak from the packing seal interface during one full STROKE (Figure 50). Many times this can be accomplished by placing a sheet of paper below the cylinder end.

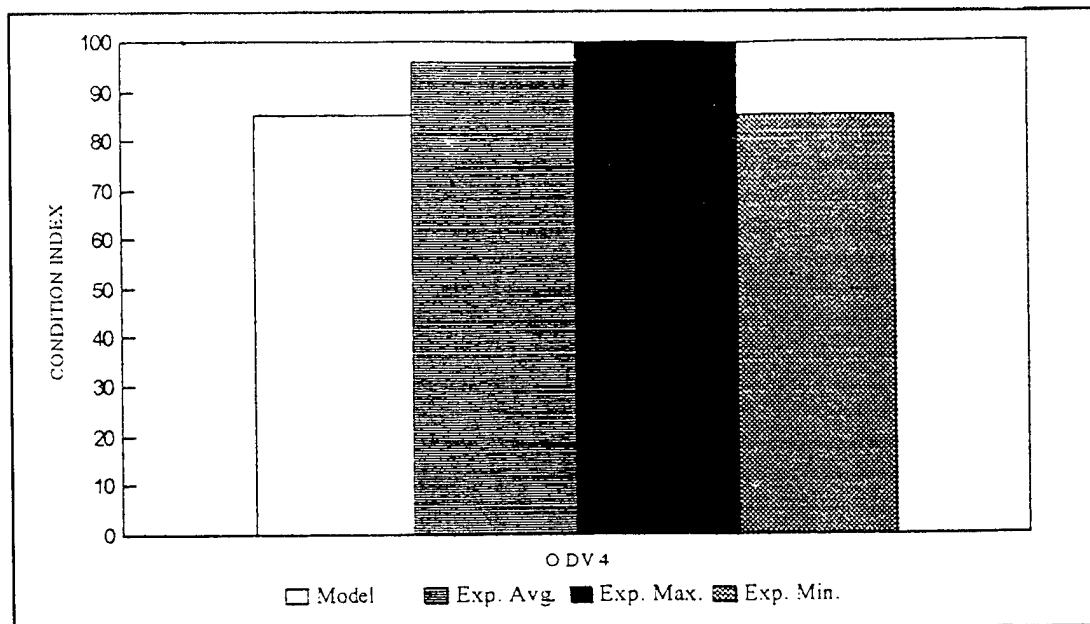
Figure 51. Anchorage movement/deterioration: hydraulic cylinder assembly.

### **Anchorage Movement/Deterioration: Figure 51**

In only one case (Ortona Vertical Lift Gate #4) was any anchorage deterioration observed (corrosion of nuts). The calculated CI was 85. For the other hydraulic cylinder assemblies, no deterioration was recorded by the experts and the calculated CI was 100.

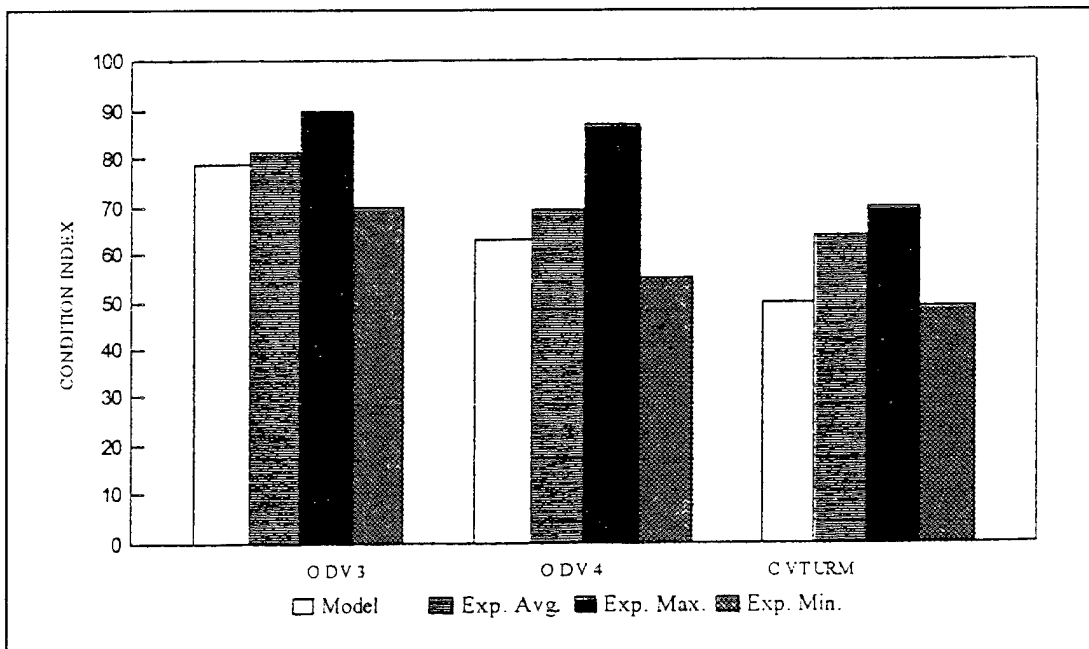
Figure 54. Drift: hydraulic cylinder assembly.

## **Drift: Figure 54**

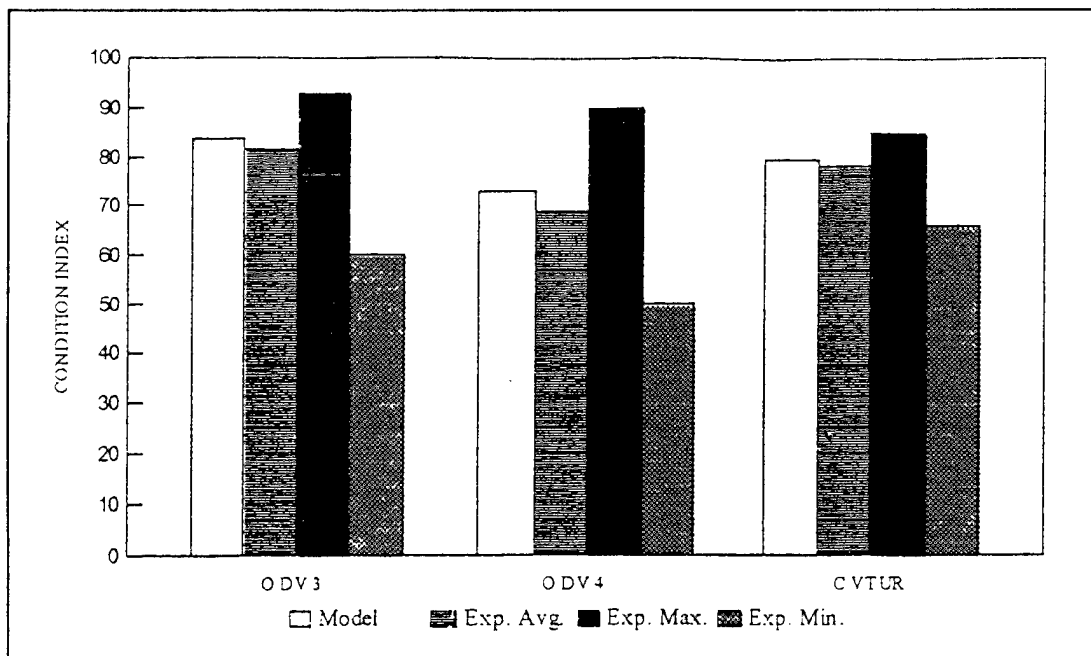
Figure 55. Hydraulic cylinder assembly CI.

## **Assembly CI: Figure 55**

The assembly CI for the hydraulic cylinder assembly was calibrated for three assemblies. The model CIs closely approximated the experts' average CIs for all three calibrated assemblies.

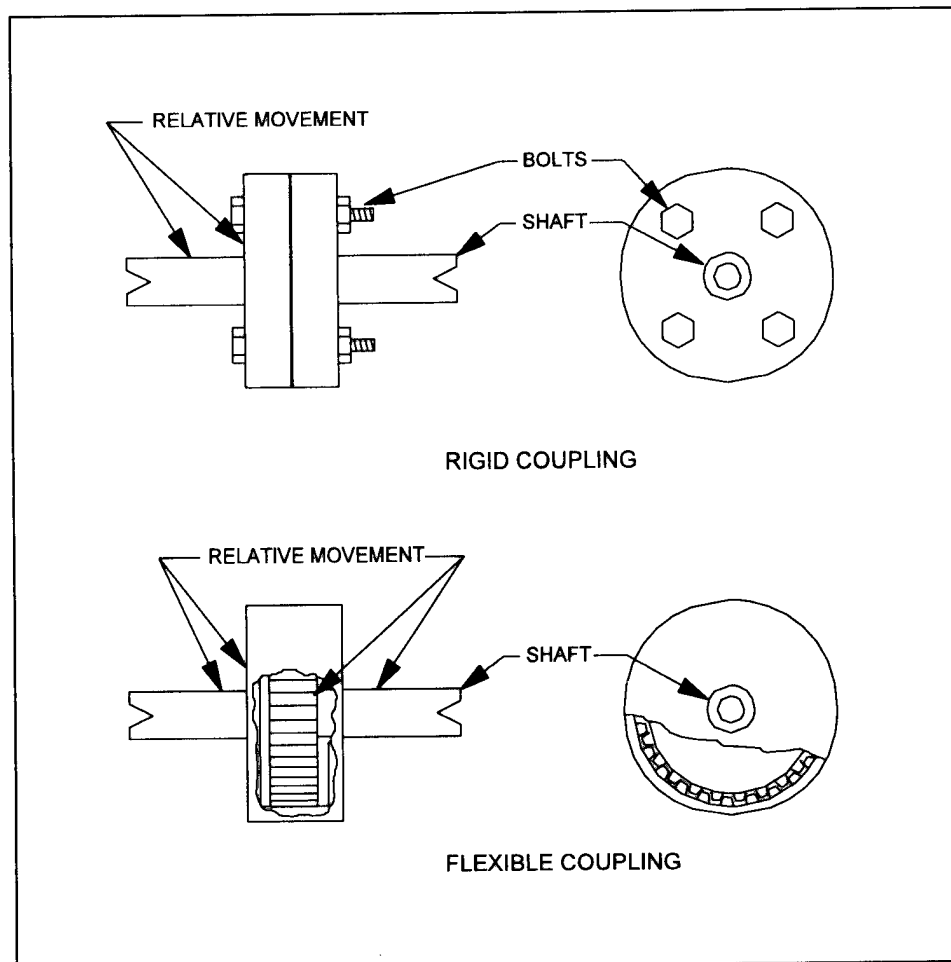
Figure 56. Coupling relative movement measurement.

A FLEXIBLE COUPLING is an internal gear (Figure 56). A small amount of lateral movement of the coupling may occur in a flexible type coupling. A RIGID COUPLING is one for which no movement should occur, either in the lateral direction or with respect to the shaft. Rigid couplings are often bolted together.

Observe the shaft and hub when the operating equipment starts and stops. Record if there is any RELATIVE MOVEMENT BETWEEN THE INPUT SHAFT AND the HUB. Also record any RELATIVE MOVEMENT BETWEEN THE OUTPUT SHAFT AND the HUB. If either distress is marked yes, record if THE MOVEMENT IS EXCESSIVE. If the coupling has a keyway, and the key is loose or there is obvious long-term movement, the movement is excessive.
